# PROPERTY INSPECTION REPORT

Concerning: **1107 Jewell St. #B Austin, TX 78704**

**February 10, 2022**

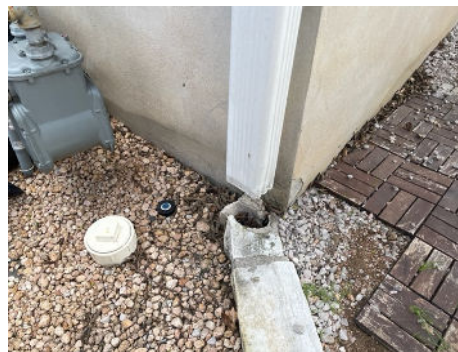
Missing elbow on gutter downspout

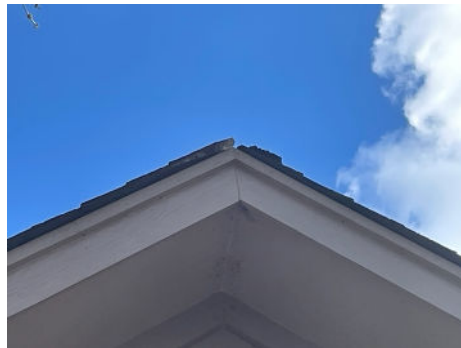
- There is damage to the rake and ridge edge shingles on the front gable of the home. This damage to the rake and ridge edge shingles is most likely caused from previous tree limb contact.
- Granulation loss was observed around the rooftop. The fiberglass (shiny threads) in the shingles was visible around the roof which is a sign of an aging roof covering. Further evaluation of the roof by a professional roofer is recommended.
- There was no metal drip edge flashing on the roof (drip & rake edges) as now required in current standards.

Damage to ridge/rake shingles on front gable

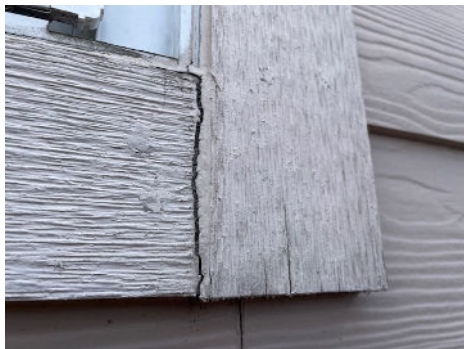
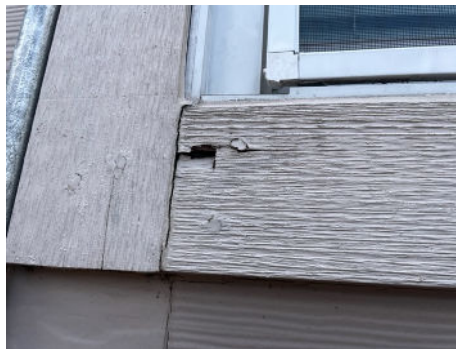
- There are areas of minor decay on the wood trim boards around the windows. This is typical for a home of this age with this product (wood) and these areas should be monitored and eventual repair/replacement should be considered.
- Exterior silicone sealant (caulk) shrinkage was observed randomly around the exterior walls of the home. Properly sealing voids could help prevent possible water and/or pest intrusion over time.
- The rear lower Hardie plank siding has a nail pop.
- The front gate is considered to be in poor condition. Repair/replacement is recommended.

Minor decay on wood trim boards

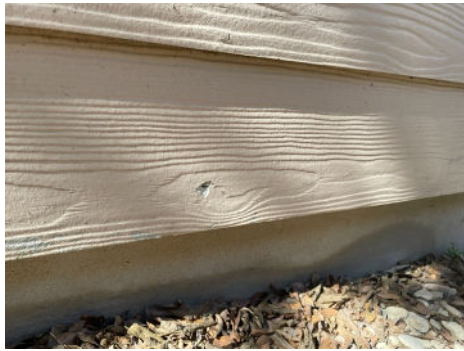
Nail popping in rear Hardie plank siding

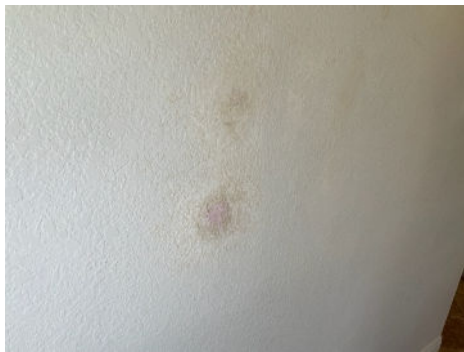
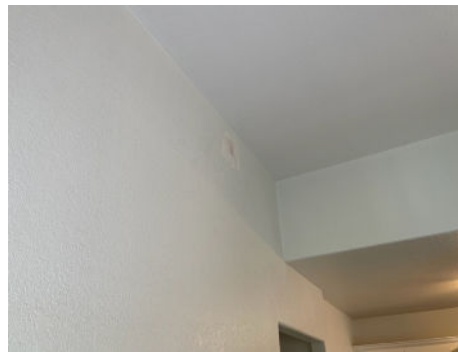
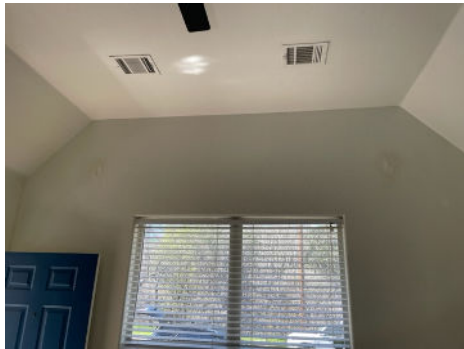
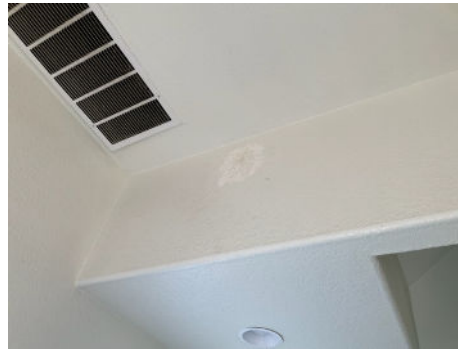
- Sheetrock patchwork/repair was observed randomly around the home. During the inspection, there was a Handyman making random repairs. (3-10-23)
- There is missing caulk around the tub faucet in the tub/shower of the upstairs hall bathroom. This should be sealed to prevent the intrusion of unwanted water into the wall cavity.

Interior sheetrock patchwork around walls

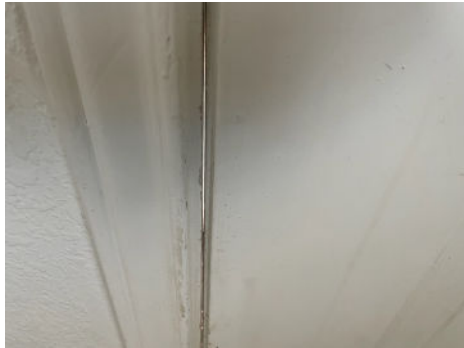
- Weather stripping around the front exterior door does not seal properly (light can be seen around the door edge from the interior) - the door may need adjustment or weather stripping may need to be added. Damage to the weather-stripping was observed along the knob side of the door.
- The door sweep on the front exterior door does not seal properly (light can be seen around the lower door edge from the interior) - the door/threshold may need adjustment or a newer door sweep may need to be added.

Weather-stripping not properly sealing

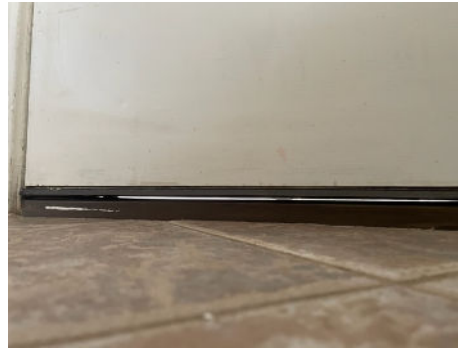
Front exterior door sweep not sealing

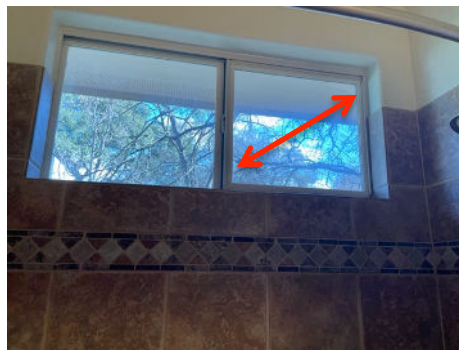
- The window in the downstairs bathroom has fogging in between the panes which is most likely caused from faulty seals. The windows in the home should be further evaluated by a window specialist to determine the extent of any failed seals.
- Select window screens were being stored in the rear yard along the home.

Fogging in bathroom window

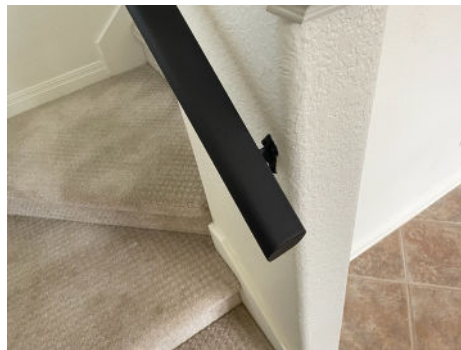
- The interior staircase handrail does not turn into the wall at the bottom as now required in current building standards.

Hand railing not turned into wall at bottom

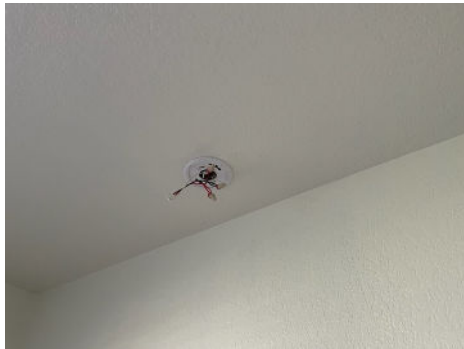
- Current standards require that all sleeping areas and all hallways adjacent to sleeping areas be equipped with a working smoke detector and that these smoke detectors be electrically powered and tied together (when one goes off they all go off). This house has some missing smoke alarms. During the inspection, there was a Handyman making random repairs. (3-10-23)
- No carbon monoxide detectors were observed and these are now required in current building standards since gas fired appliances or an attached garage are present in this home.
- There is a loose electrical outlet in the kitchen countertop area. This should be secured to avoid possible injury/accident.
- There is a loose electrical outlet in the upstairs bathroom countertop area. This should be secured to avoid possible injury/accident.
- The upstairs ceiling hall light did not work at the time of the inspection (no bulb).

Missing smoke alarm in bedroom

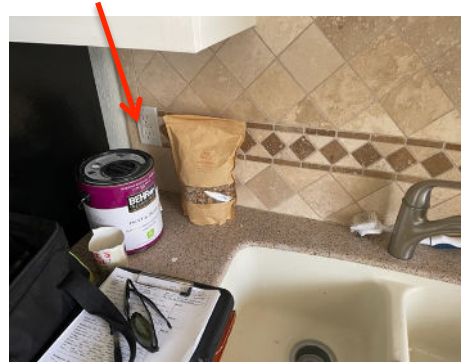
Loose wall outlet in kitchen

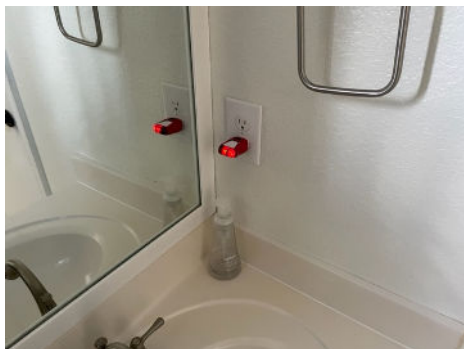
Loose wall outlet in bathroom

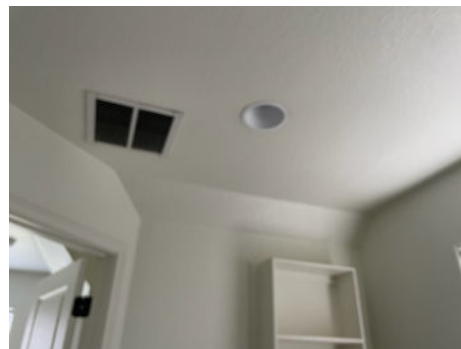
Upstairs ceiling light not working

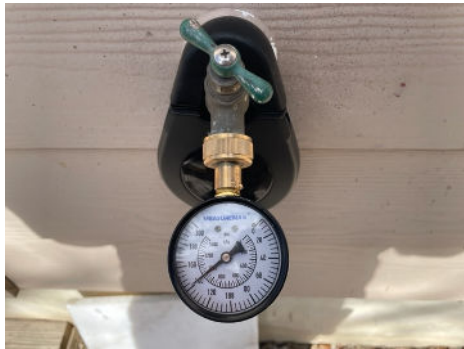
- The recorded water pressure at this home is **140** psi. Recommended water pressure for residential applications is 40-80 psi with 60-65 being considered ideal. High pressure on the water supply system can have the effect of wearing out seals, valves, piping and other faucet components prematurely as water is under constant pressure at all times even in the “off” position. If your water pressure is consistently above 75 psi, it is recommended that you consider a conversation or a review with a licensed professional plumber to discuss solutions including a pressure reducing device if so advised.

140 PSI- Recorded water pressure for the home

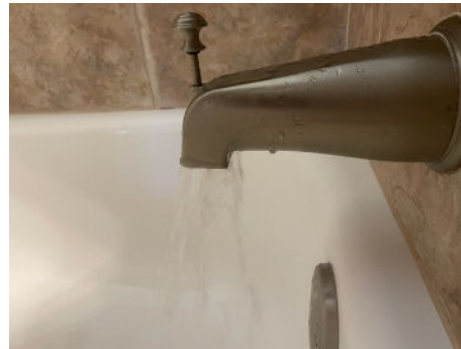
- Both of the bathroom tub/shower diverters are faulty and will not allow the normal water pressure switch from tub faucet to shower head as intended. Further review by a licensed plumber is recommended.

Faulty diverters in tub/showers

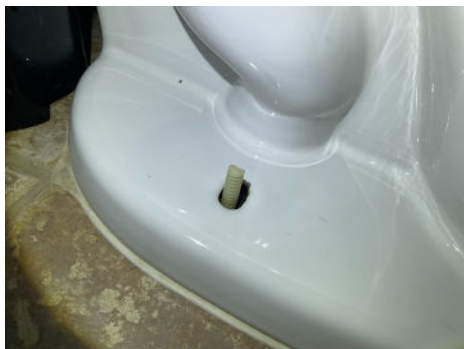
- The upstairs bathroom toilet has a missing anchor bolt (left side). Further review by a licensed plumber is recommended.
- Some or all of the exterior hose bibs have no anti-siphon devices as current standards require.

Missing anchor bolt on upstairs toilet

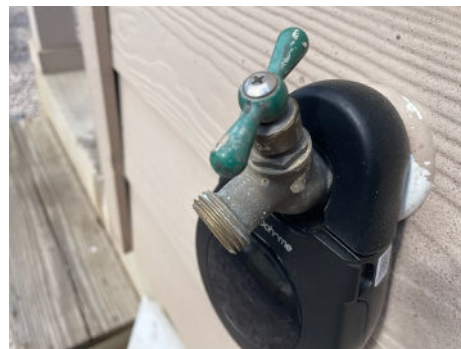
No anti-siphon device (back-flow preventer)

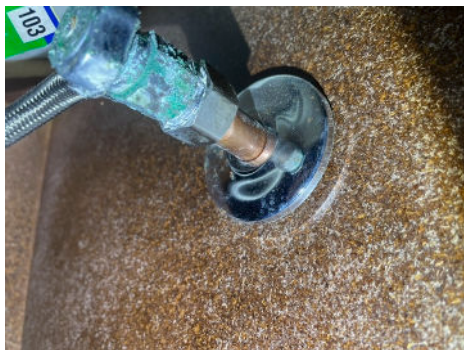
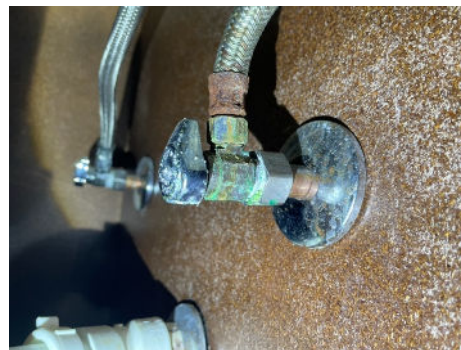
- Corrosion/rust was observed on select water supply fittings and/or water supply shutoffs randomly around the home. It is recommended that a licensed plumber review and evaluate the plumbing fittings and shutoffs in the home.

Corrosion/rust on select water shutoff fittings

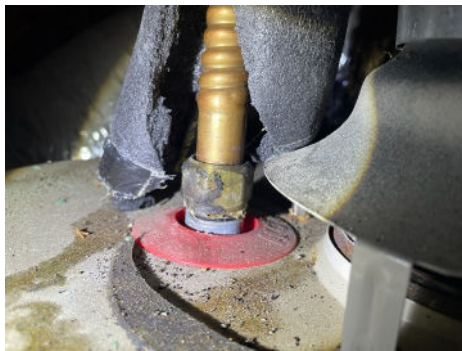
- Corrosion on the water supply line fittings was observed and creates a higher likelihood of tank failure.
- There was no 2-gallon thermal expansion tank installed on the cold water line for the water heater. In current building standards, a 2-gallon expansion tank installed on the water heater(s) is required to help improve the overall efficiency/longevity of the plumbing system in the home (see current local codes and/or AMI (according to manufacturer's instructions).

Corrosion on water supply fittings

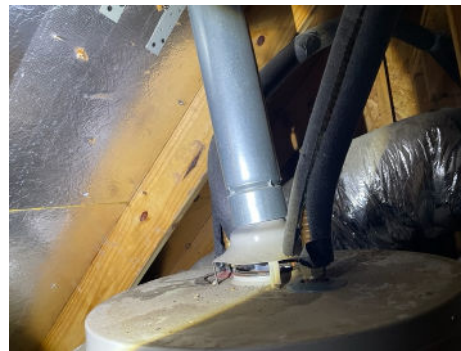
No 2-gallon thermal expansion tank
