# PROPERTY INSPECTION REPORT

Concerning: **1107 Jewell St. #B Austin, TX 78704**

**February 10, 2022**

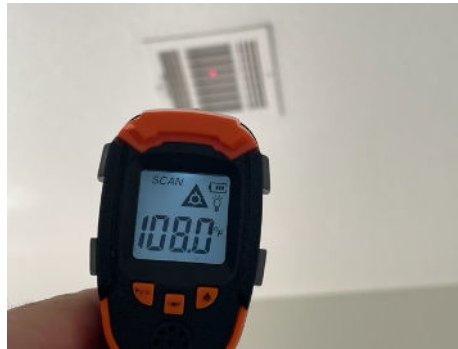
*Comments:* The differential temperatures between the output air of the heating systems measured at selected registers and the input air measured at the return air grills closest to the thermostats are within the acceptable performance ranges for these type systems (108/65). Temperature measurements are taken with a hand-held device accurate to + or - 5 degrees. Gas piping, flue vent piping and flame characteristics are suitable for this type system.

108 Degrees- Recorded hot air supply temperature

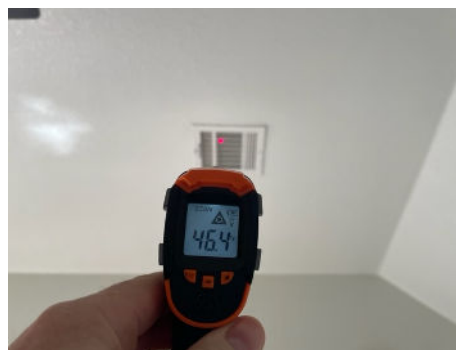
*Comments:* The differential temperatures between the output air of the cooling system measured at selected registers and the input air measured at the return air grill closest to the thermostat are within the acceptable performance range for this type system (46/63). Temperature measurements are taken with a hand-held device accurate to + or - 5 degrees.

46 Degrees- Recorded cold air supply temperature

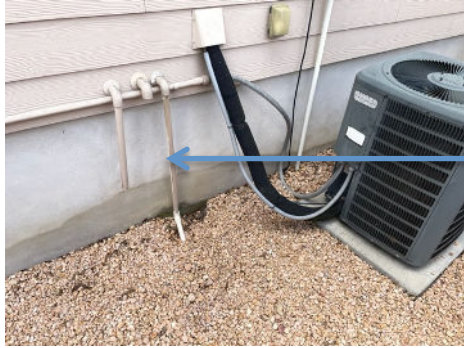
**Information Notes:** The primary AC condensate drain line is protruding from the left exterior wall near the condensing unit. The secondary condensate drain line is protruding from the exterior wall along the left side of the home above a window. This is typical in

Primary condensate drain line

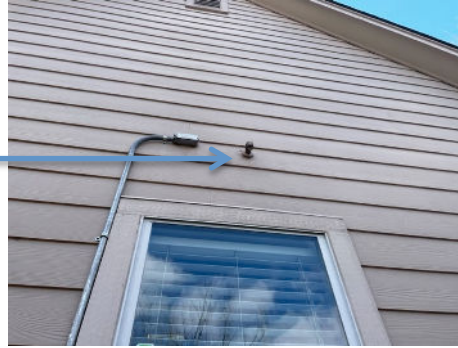
Secondary (emergency) condensate drain line

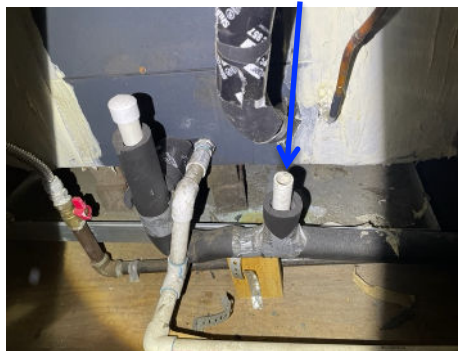
Hot water/bleach service to the primary condensate drain line

**Bleach Service:** To help avoid the clogging of your primary condensate line, you can give bleach service to the line from the unit (PVC pipe). For best and safest results, dilute 1 part bleach with 1 part warm water. Using a funnel, pour the mixture in the PVC vent pipe 3-4 times a year. Be sure to catch the mixture when it exits the primary line to keep from contaminating the yard.

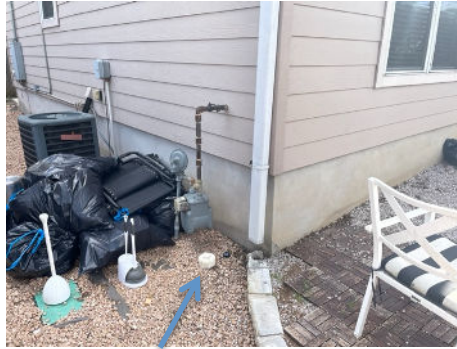
**Information Note:** The main sewer clean-outs are located in the yard along the left side.

Main sewer cleanout for the home
